MR. Y2000

Q: The headlamps on my 2008 Z06 have fog in them in the morning. Should I be concerned?

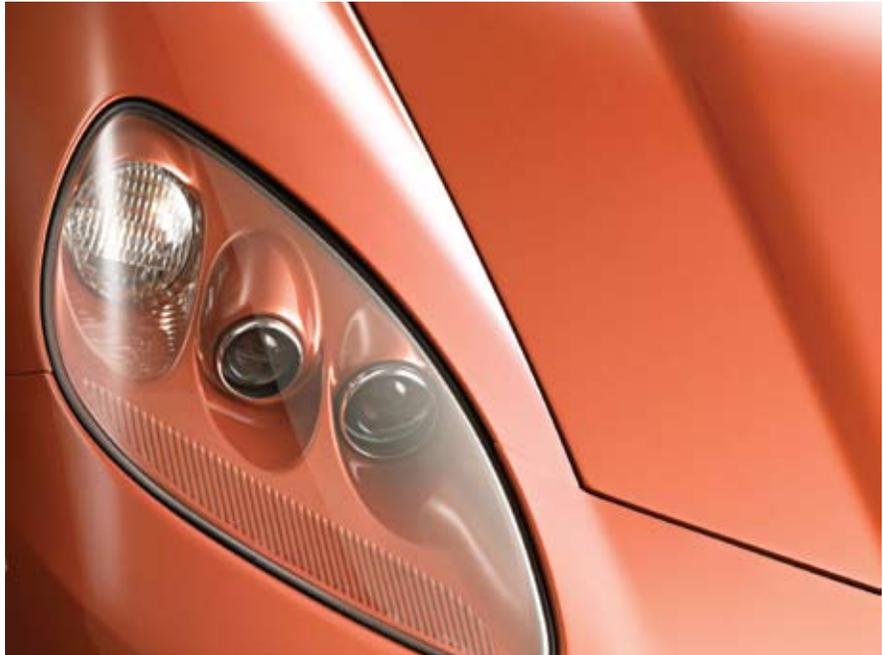
Mr. Y2000: Dear Foggy — Not to keep you *in the fog* about this, but, NO, you don't need to be concerned. The condensation (fog) is a result of the air inside the headlamp being warmer than the cooler air surrounding the headlamp outside — this is NORMAL. As the hot air cools inside the lamp, the lamp draws in cooler outside air. When humidity is high, the air being brought in is laden with moisture. So the moisture collects on the inside of the lens surface and shows up as condensation. As the lens heats back up, the next time your Z06 is driven with the headlamp on, the condensation is burned off and disappears.

The cooler the air, and the more humidity in the air, the more condensation you may find on the lens in the morning. Think of it like your bathroom mirror after taking a shower. In the case of the bathroom, you have warm, moist air collecting on a cool mirror surface and it creates condensation (fog). The same principal of physics applies here, only in reverse. When the hot headlamp lens comes in contact with cooler moist air at night and you have the *badda bing, badda boom*, effect (fog). GM does have a Bulletin out to address this. It basically says that this concern is NORMAL. But if you find that the condensation has not burned off after two hours, then the Bulletin instructs the Dealership to change the lamp.

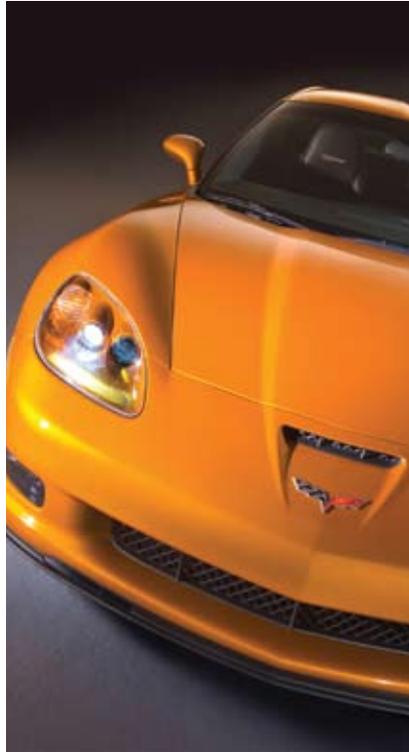
Mr. Y2000: Hmm — I'm assuming you're referring to dark spots under the front protector (bra) covering the front of your Corvette...**CORRECT?** Yes, it is fairly common when any vehicle is washed and a protective cover (bra) is installed. The water will seep behind the bra and it just sits there, unless the bra is removed and the body is dried thoroughly and the bra is also allowed to dry. The situation here is that you are trapping moisture behind the bra, and without air flow, it can definitely turn into mold. In most cases, mold shows up on the fascia or around the front emblem. Warm soap and water will generally remove the molding areas from the front of the vette.

It is important that any time a bra is used on a Corvette that it fits snug against the body. If it is allowed to flutter in the airstream while driving, it can cause *painful* paint abrasions. It is also important to follow the bra manufacturer's instructions on washing and drying. Dirt and grit can become embedded in the fabric between the bra and the Corvette's body and it can scratch the beautiful clear coat finish of your vette.

When a bra is installed and used properly, they do an excellent job of protecting the front of your Corvette from road hazards, bugs and the dreaded "what-not" of the roads. We recommend strongly that when your Corvette is not in use, take the bra off and allow the finish of your Corvette to breathe.
